NEXT'S OXFORD STREET STORAGE SPACE TANKED BY TRITON

Case Study

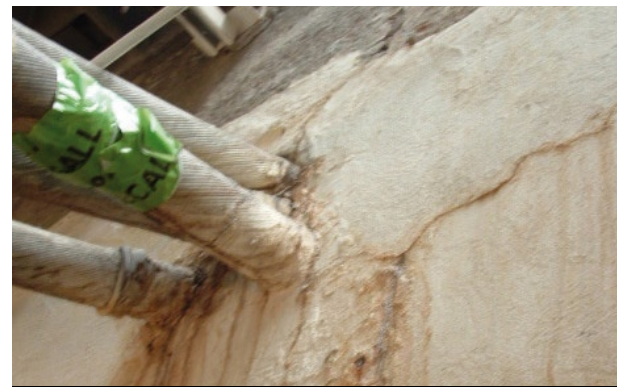
Water and damp ingress had caused cracking and debonding of the original waterproof render particularly on the earth retaining walls in the light wells. Water was entering the building to such an extent in some areas that a temporary internal guttering system leading to plastic dustbins had been installed!

Render cracked and debonded in light wells

MGA's team initially removed all the cracked render, but retained any solid material to minimise damage to the substrate. Patch repairs were then made where necessary with 3:1 sand cement render. Trimol 23 epoxy adhesive was then applied as a primer to ensure a good adhesion for the subsequent tanking system.

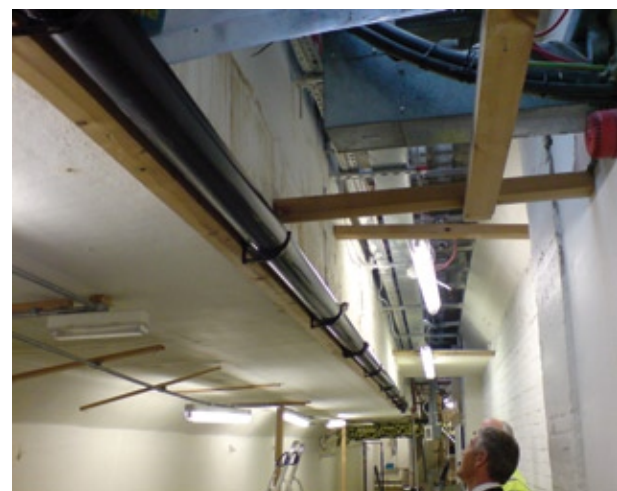
Temporary guttering system in place

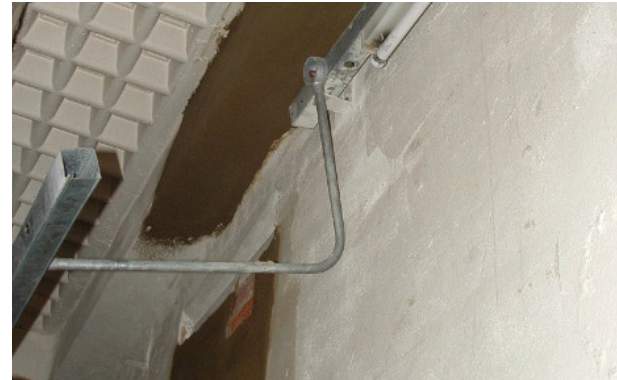
Patch repairs with 3:1 sand cement render

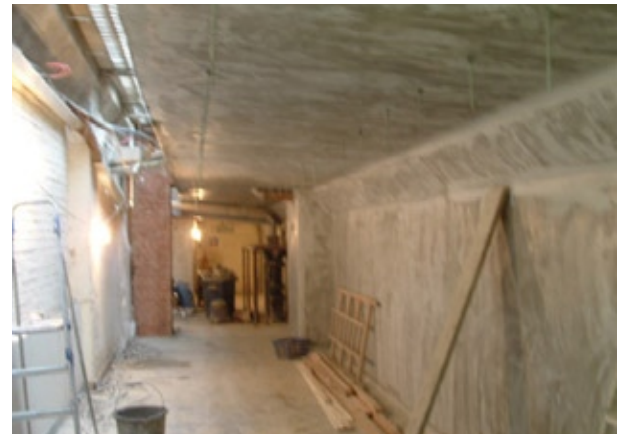
After the installation of the T55 tanking system, before painting

Finally two coats of Triton's TT55 tanking system was applied to all soffits and walls to provide a damp proof 'membrane' layer. To accommodate the movement and vibration caused by the traffic and underground trains in the area, Triton's TTME, an elasticising additive, was incorporated into the TT55 slurry mix to form a flexible waterproofing coating which was then painted.
