MEMBRANES MEAN FASTER REINSTATEMENT FOLLOWING FLOOD

Flood remediation systems from Triton Systems helped minimise the time taken to reinstate a terraced property after flooding; and allowed the owner to move back many months earlier than her neighbours.

Case Study

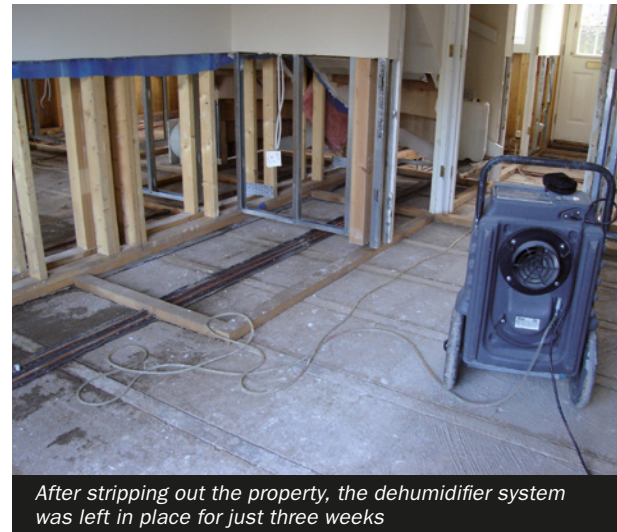
After stripping out the property, the dehumidifier system was left in place for just three weeks

Stripping out started immediately to remove the plaster up to a metre high, the fibreglass insulation from the cavity walls, the chipboard floors and PE membranes and insulation. Every remaining surface was then power washed and sprayed with a sanitiser. The dehumidifier system was then left in place for three weeks.

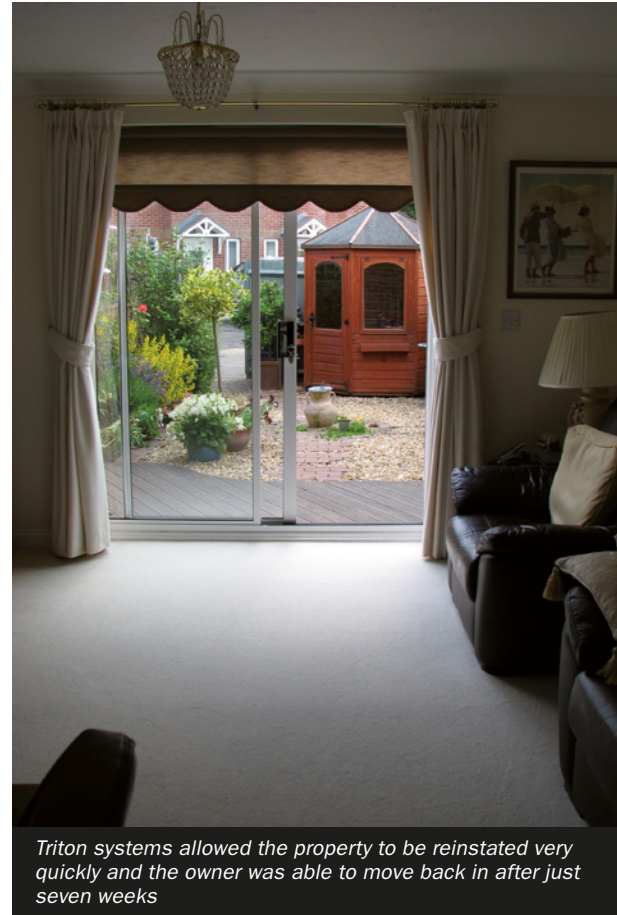
Triton systems allowed the property to be reinstated very quickly and the owner was able to move back in after just seven weeks
